Quarterly Report

Explosives Inspectorate

April, 2024

Resources
Safety & Health
Queensland

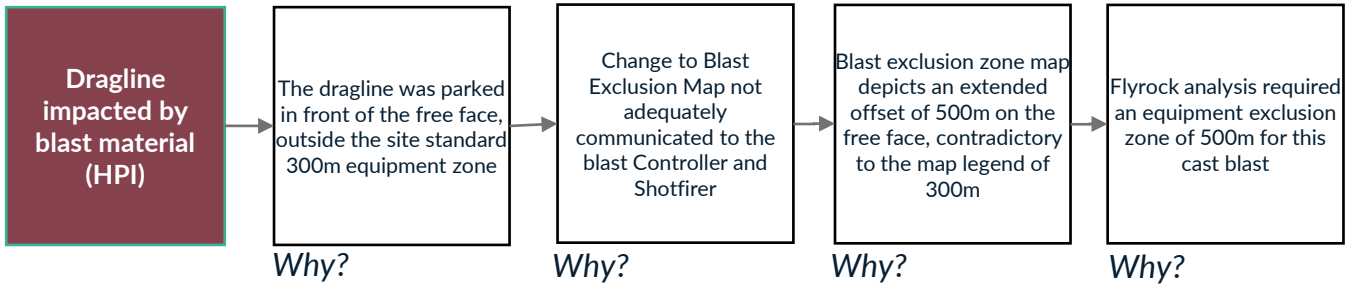
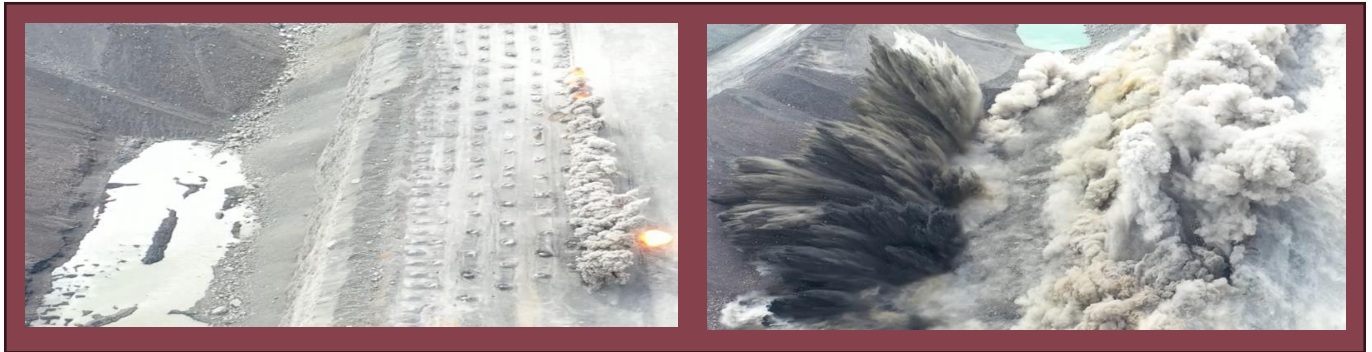
Figures 1 & 2 – Photos showing the blast and ejected blast material

The material from a cast blast has caused water-logged material in the bottom of the pit to be squeezed out and projected over the spoil impacting the dragline. The dragline was parked in front of the blast, outside the standard 300m equipment exclusion zone. This blast required a 500m exclusion zone in front of the free face, this change was not adequately identified on the blast maps or appropriately communicated.

- The increase in the exclusion zone was not effectively communicated.

- The increase in the inclusion zone was not identified adequately on the Blast Exclusion Map Prior to firing.
- Flyrock analysis does not consider secondary material being projected from the blast.

- Communicate any change to exclusion zones of blast management plan to all relevant personnel.
- Identify and remove people and equipment from directly in the line of fire from blasts.
- Review Standard Operating Procedures to address the risks inherent to blasting into bodies of water.

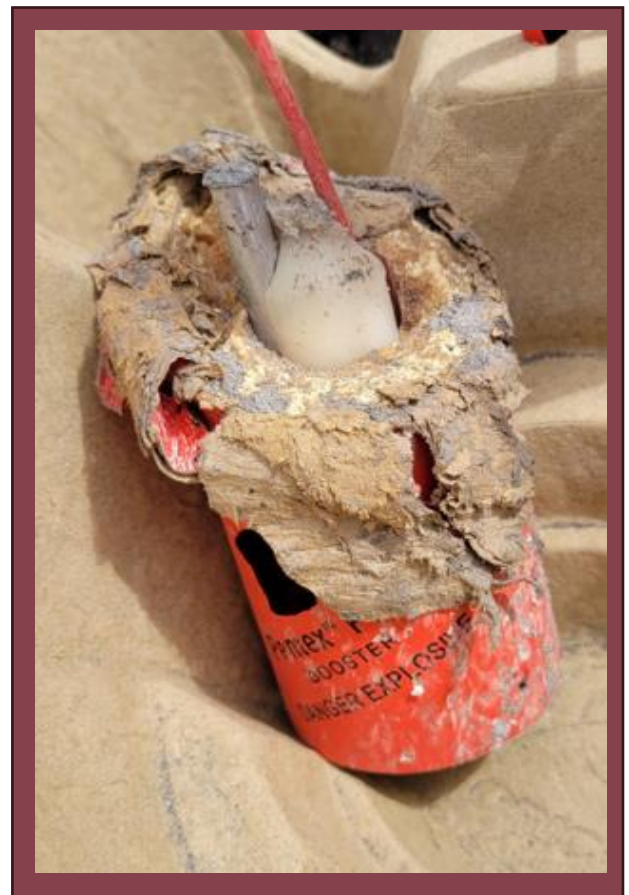
Figure 1 – Eroded booster with detonator

A triple primed blast hole was stemmed prior to loading bulk explosives product. There was a potential for unplanned detonation through erosion by stemming of a non-electric detonator and booster. Another two (2) detonators and boosters were damaged and lost down the hole.

- Multiple bulk products were being loaded into the blast, requiring the need to use flagging to identify different loading requirements.

- Operators and offside failed to check loading and stemming requirements for all blast holes.

- Job step focus.
- Effective control and communication of activity by the Shotfirer.
- Develop and implement control to positively identify unloaded blast holes.

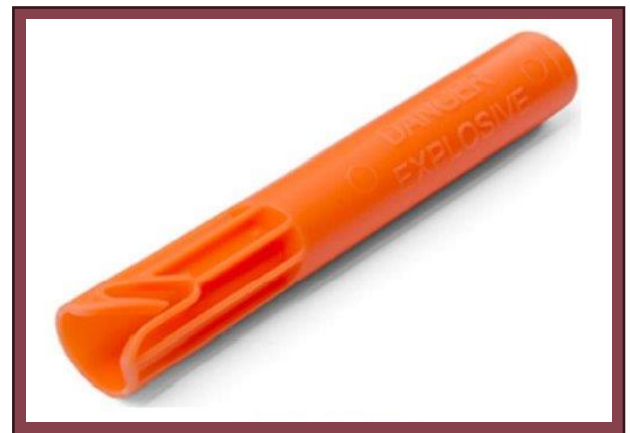
Figure 1 – Pentex D 25g booster

A routine review of an explosive stocktake record identified a missing Pentex D 25g booster. Days prior to the review being conducted, the magazine stocktake record was altered when an inconsistency between the shift count and the magazine record was noticed. It was assumed that the discrepancy was the result of a miscount. Following the review, the single cast booster was later found after further searches were conducted in a recently worked heading.

- Explosive counts were not being verified by two people as per the site procedure.
- The assumption that the discrepancy was a clerical error prevented further investigation.
- The identified discrepancy was not escalated to senior personnel on site

- Persons in charge of an explosive magazines must ensure that regular stocktakes of explosives are carried out to identify discrepancies in holdings or records.
- Explosive incidents are to be reported immediately in the approved form under s56 of the Explosives Act 1999.
- Adequate training of employees in incident procedures is a critical step in all safety and health management systems.
- When discrepancies are identified and not immediately acquitted enact your security plan.
