MAY 2024

# May 2024 Incident periodical

COAL MINES INSPECTORATE

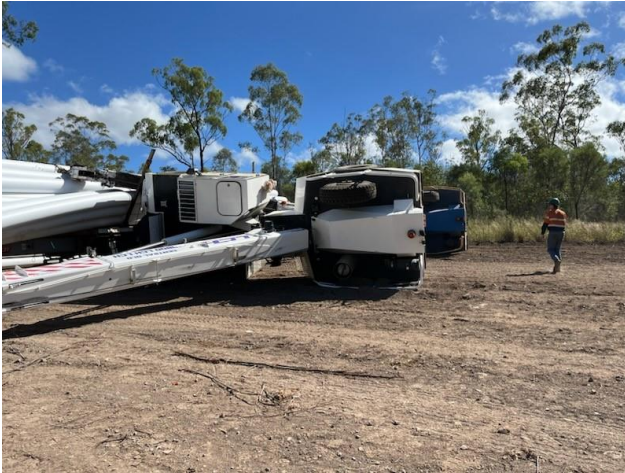
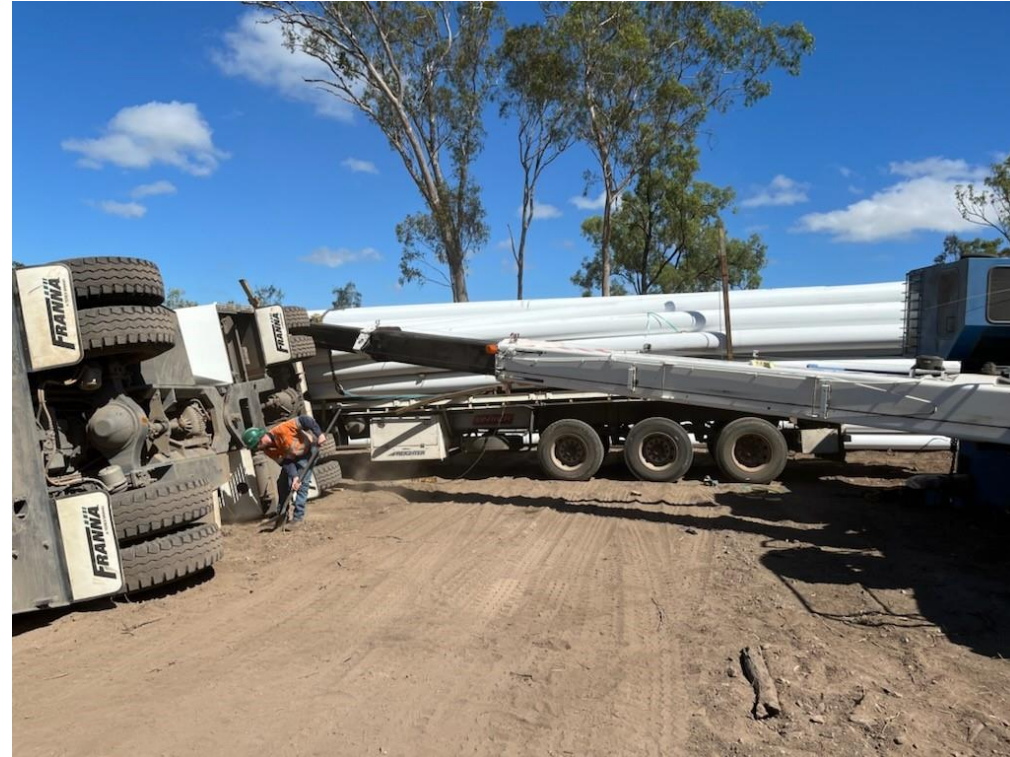
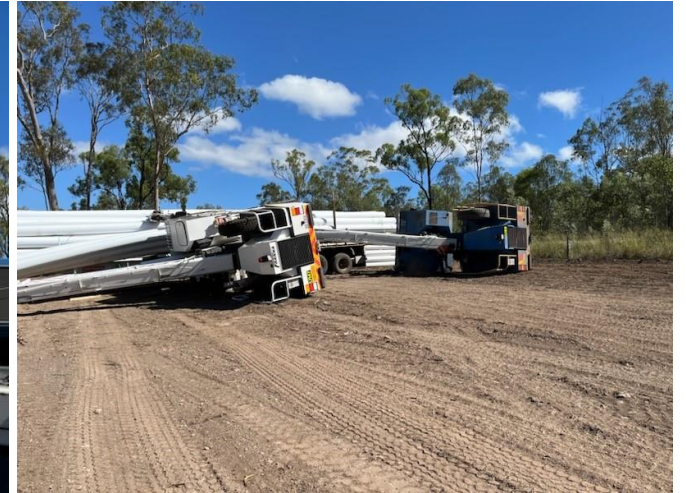
# Franna cranes roll over whilst lifting pipework

- Whilst unloading a rack of poly pipe utilising two 25t Franna cranes (dual lift), the first crane lost stability and started to tilt just before tipping onto its side. This has caused the second crane to lose stability and tip onto its side.
- One of the crane's system data registered a 2-degree increase in slide slope deration. This slide slope increase put this crane outside of its operating limits of 5 degrees.
- Sites must ensure preparation of the pad angle is considered for all lifting activities. Review the pad preparation process of the specification to ensure a range can be selected and requirements are clearly understood by production or whoever is cutting the pad. Associated risk assessment documentation should include correct crane selection and a risk assessment as part of the process for dual lifts.

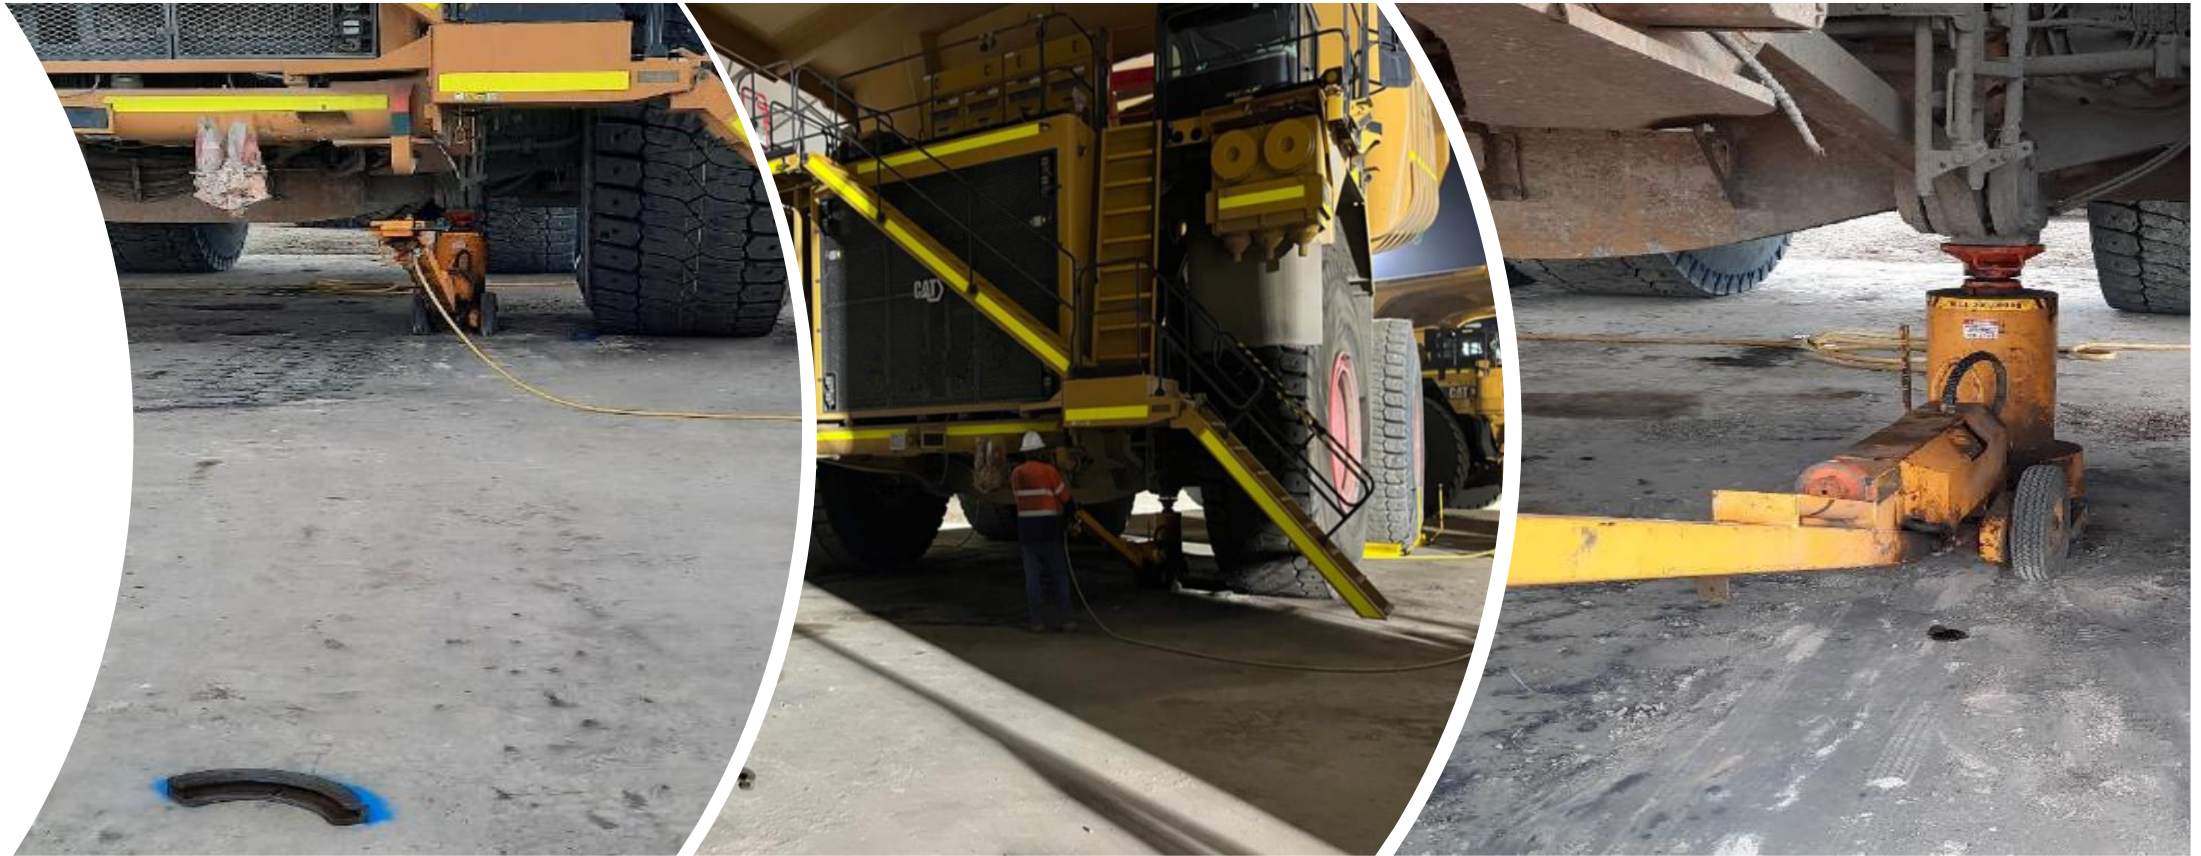
# Jack locking system failure

- Following the changeout of the position 1 tyre, a tyre fitter was lowering a truck using a pneumatic 200-tonne jack when the jack locking system failed.
- This resulted in some bolts from the guard, bolts from the locking clamp rings failing or shearing, and the locking mechanism coming apart with some pieces landing up to 9 metres from the jack's location.
- The failure was due to not allowing the Jack to raise enough to disengage the locking mechanism.
- Sites must ensure formal training is in place for the use of jacks, and there is a system of work in the SHMS that allows tyre fitters to be familiarised with different style Jacks.
- If possible, the fitment of a dead man system is recommended for the sites specific jack brands.

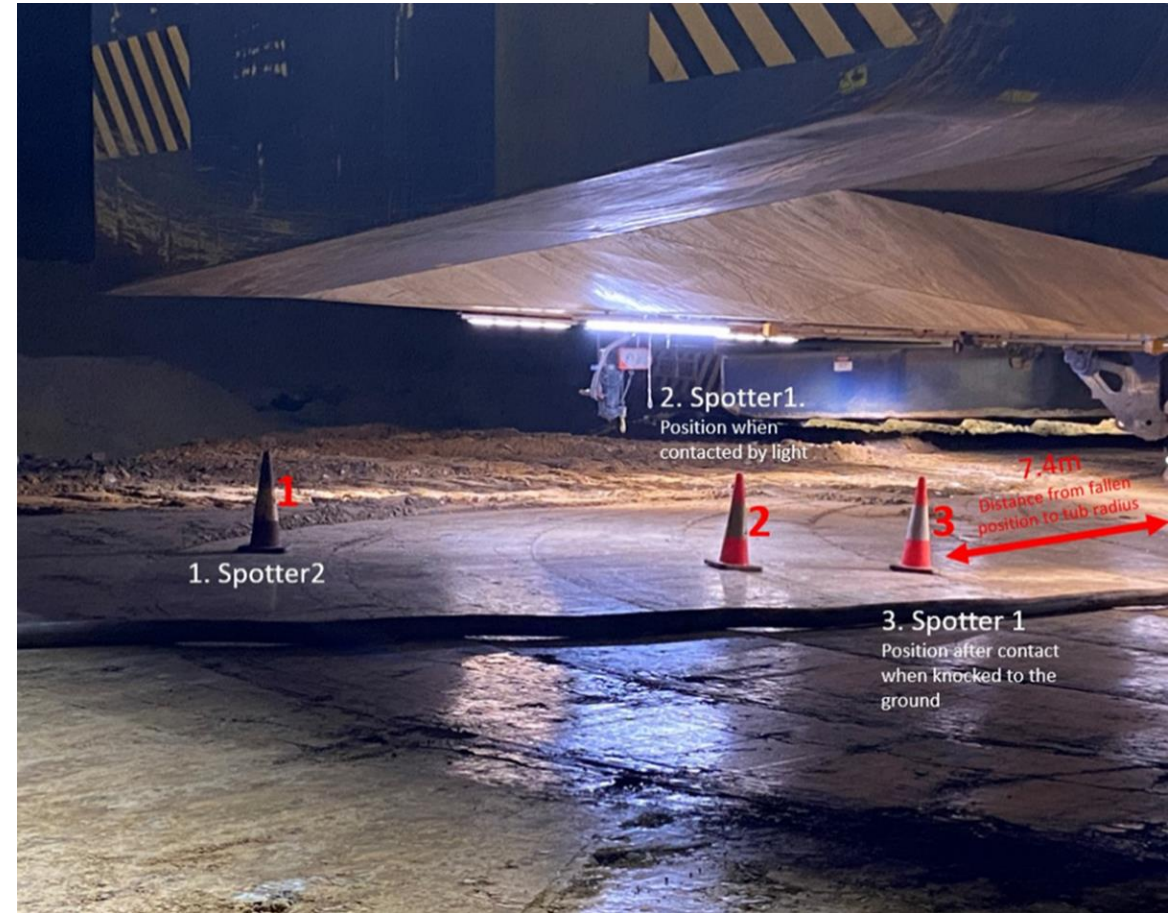
# Coal mine worker struck by rotating dragline

- In January 2024 a CMW within the dragline operational swing boundary was struck by a rotating dragline upon completion of cable relocation works (refer [Safety Alert No. 444](#)).
- In 2021 a CMW died after being injured in a similar incident (refer [Safety Alert No. 403](#)).
- Multiple HPI reports of draglines contacting manned and unmanned mobile equipment have been received by the Inspectorate (refer [Safety Bulletin No. 162](#)).

- Mines must review SHMS procedures, controls and their effectiveness for working around plant.
- Reliance on administrative controls has proven to be ineffective and higher order controls including collision avoidance systems must be considered.

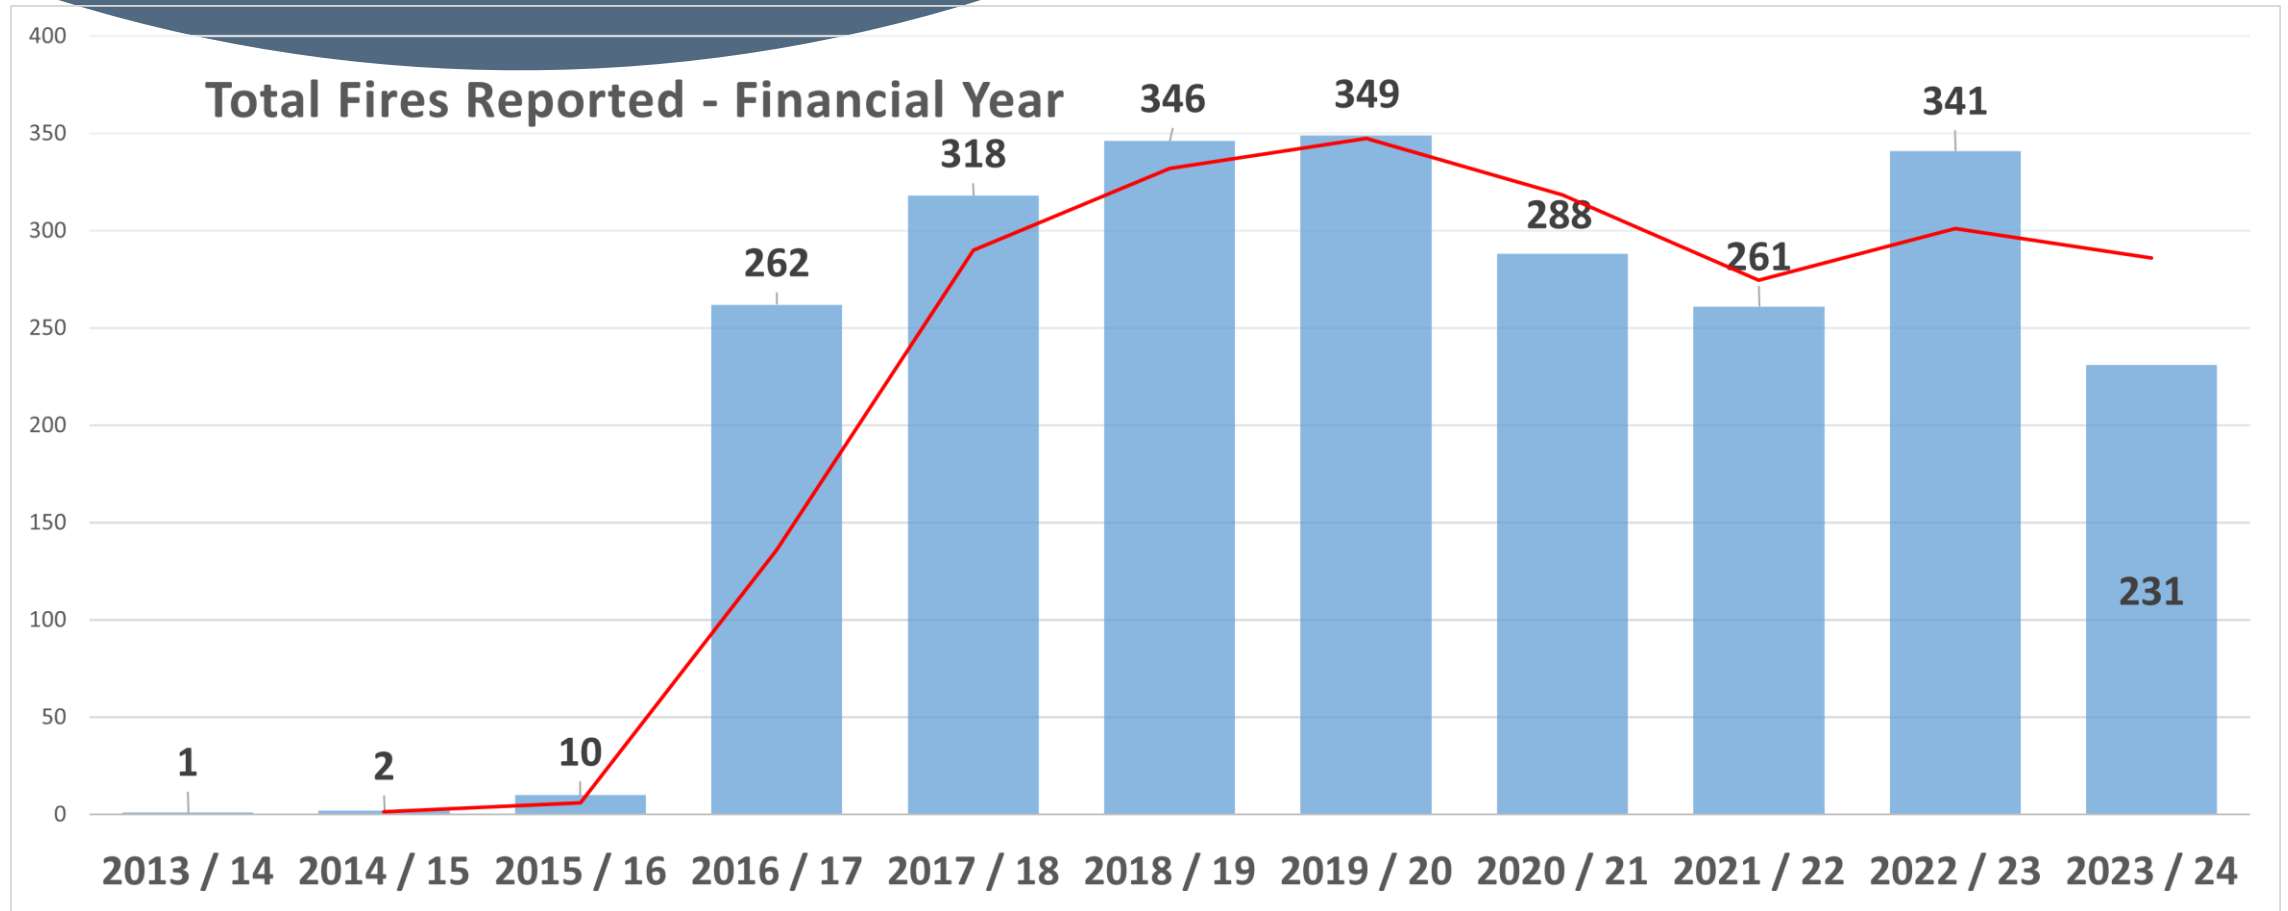
# Equipment fires

Equipment fires are not reducing within the coal mining sector

- Noticeable trending areas for fire mitigation include:
- Dozer and truck hydraulic fire:-
  - Fire occurring soon after maintenance activities.
  - Poor workmanship or lack of an exit strategy to ensure work completed is of a high standard.
  - Poor hydraulic hose strategies – not replacing critical hoses at the appropriate intervals.
- Dozer and truck electrical fire (HV and LV):-
  - Fires initiated from the third-party fitment of isolators and E Stops. – Do you have a strategy to inspect these components regularly internally?
  - Poor workmanship and securing of wiring looms.
- Dozer and truck engine oil fires:-
  - Fire occurring soon after maintenance activities.
  - Poor workmanship or lack of an exit strategy to ensure work completed is of a high standard.
